BOONDALL BUS ACCIDENT

REPORT BY JEFF SHELBERG

10:10 am 24/10/94

Jeff. Shelberg Ambulance Site Commander

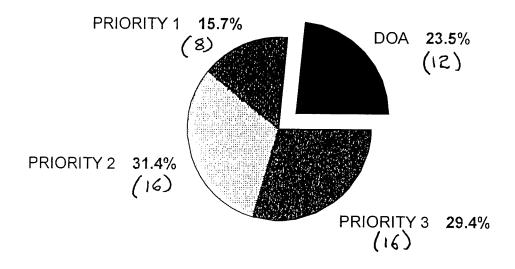
INITIAL TRIAGE

The deceased accounted for 23%(12) of the total number, and a further 29%(16) not requiring intervention to stabilise their condition. This left 47%(24) of the passengers requiring ambulance and medical intervention before transport to definitive care. (See chart on Page 4)

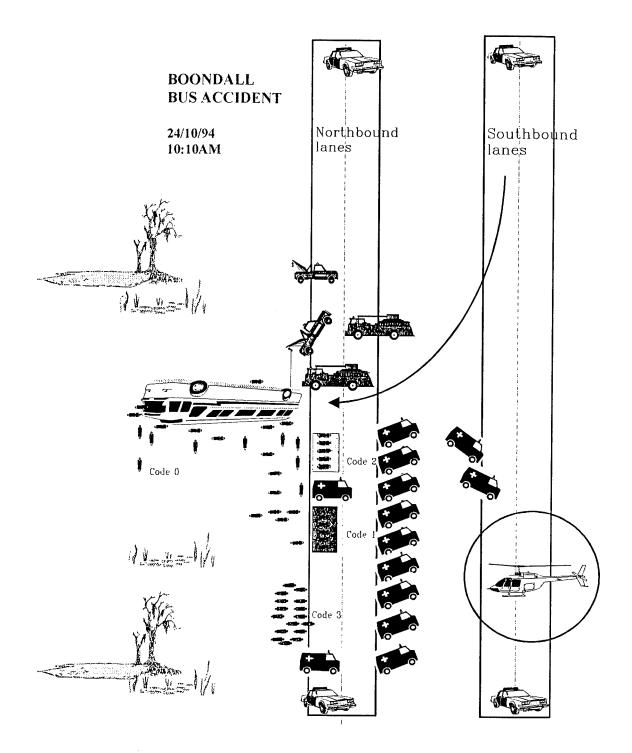
The bus was down a 10 metre embankment, and the Emergency Support Unit was deployed adjacent to this area on the road. The opposite shoulder of the road provided an ideal marshalling area, with enough room to park arriving units in a diagonal pattern to facilitate maximum use of available space and easy access for loading. Tow truck operators were asked to park all arriving vehicles. The southbound highway provided easy departure access, and was an ideal location for the helicopter landing zone. (Refer site plan page 6)
